**PHOTO
INTERPRETATION
NOTE**

**IMPROVEMENT OF JAIME GONZALES AIRFIELD
CIENFUEGOS, CUBA**

R-17/72
MAY 1972
COPY NO 68
2 PAGES

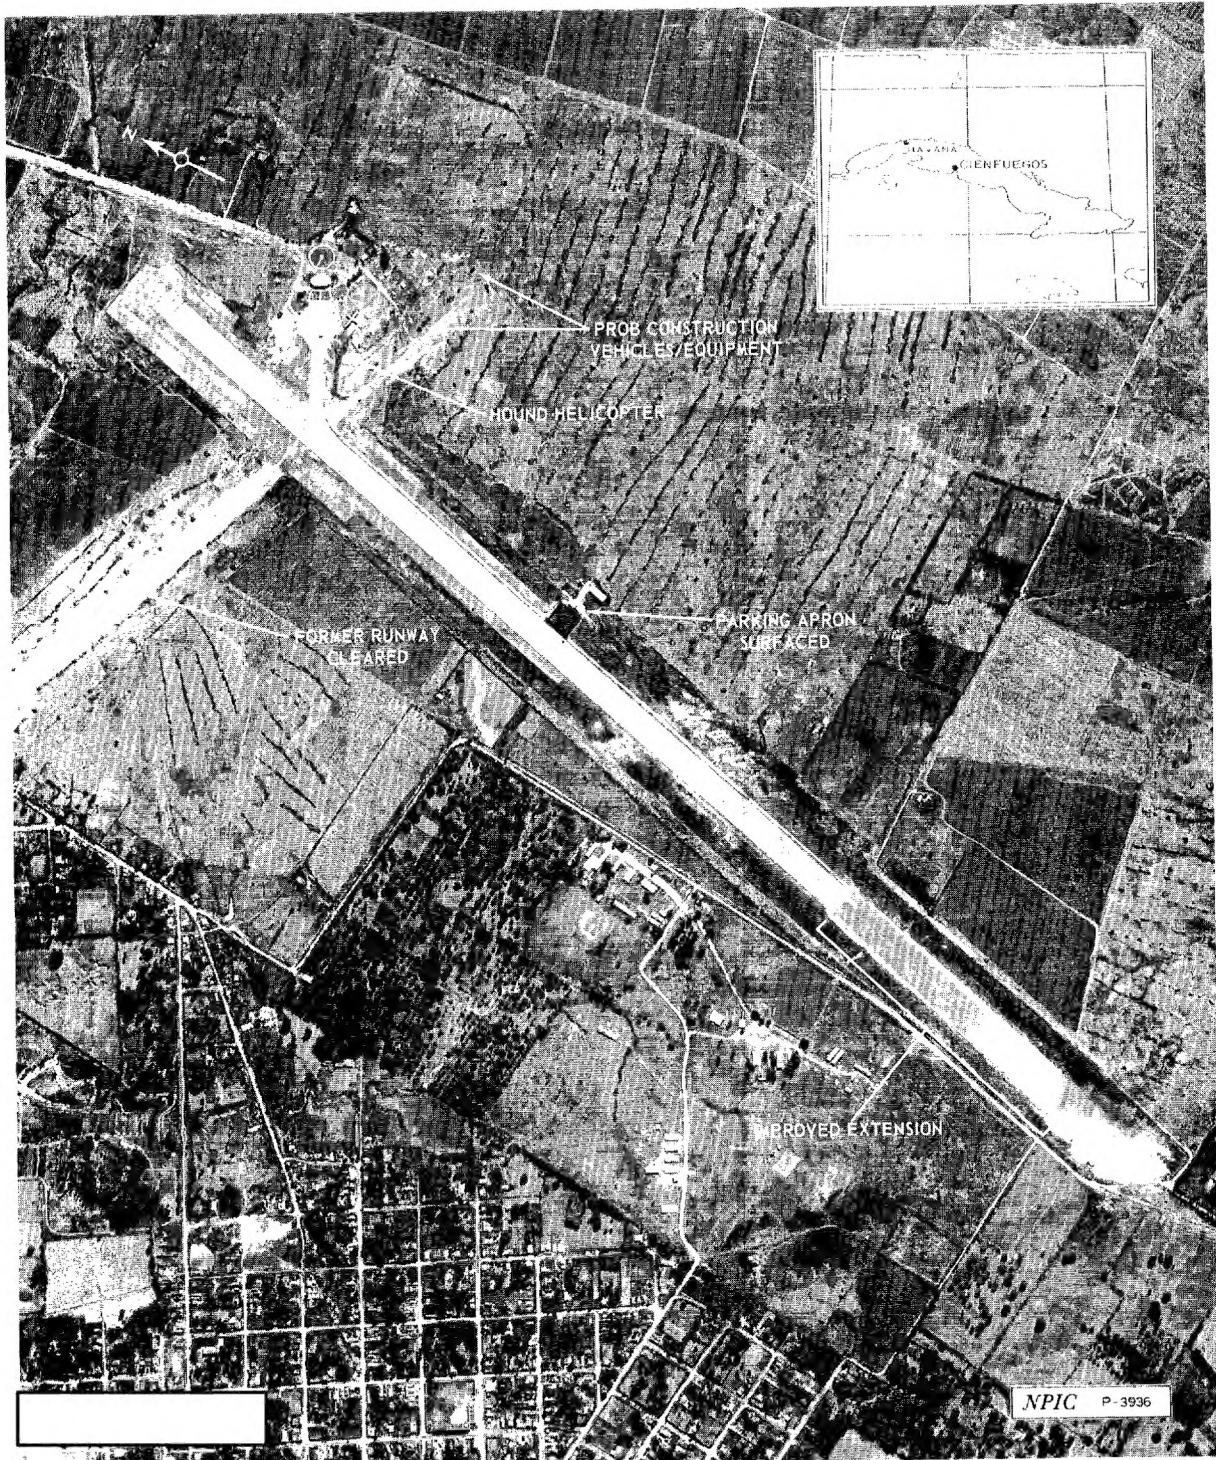
FIGURE 1. IMPROVEMENT OF JAIME GONZALES AIRFIELD, CIENFUEGOS, CUBA

- 25X1D 3. An extension to the southern end of the NNE/WSW [redacted] main runway has been cleared and
25X1D graded since [redacted]. The runway [redacted]
extension was possibly serviceable on [redacted] and
25X1D measured at least [redacted] in length
(Figure 1). The combined length of the runway and extension
25X1D is at least [redacted] and is [redacted]
25X1D wide.

- 25X1D 4. Another improvement accomplished since [redacted] 25X1D
included surfacing of a [redacted] square parking
apron adjacent to the eastern edge of the main runway.

- 25X1D 5. Vegetation has been cleared since [redacted] from the
western segment of a former WNW/ENE runway, which had deteriorated.
- 25X1A 6. FRESCO (MIG-17) aircraft were observed for the first
25X1D time at this airfield on [redacted] photography of [redacted]
25X1A [redacted] when seven were present. None have been observed
there on [redacted] photography since that date.
